MEMOIRS OF THE
ARCHAEOLOGICAL SURVEY OF INDIA
NO. 91

ANGKOR VAT

INDIA'S CONTRIBUTION IN CONSERVATION

1986-1993

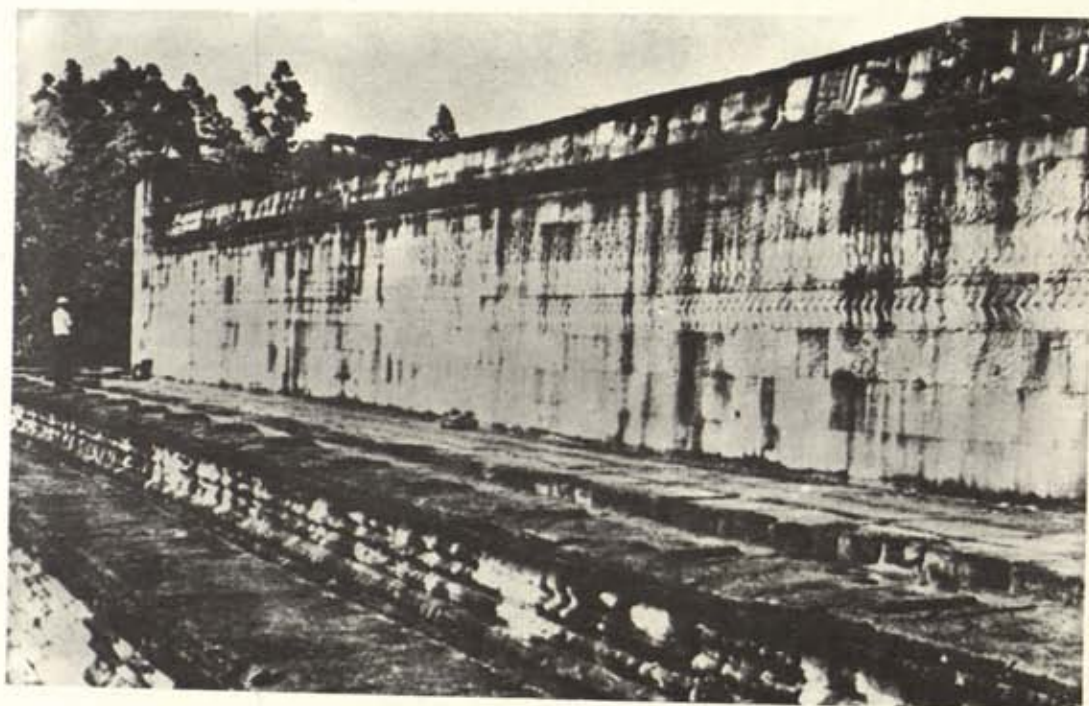
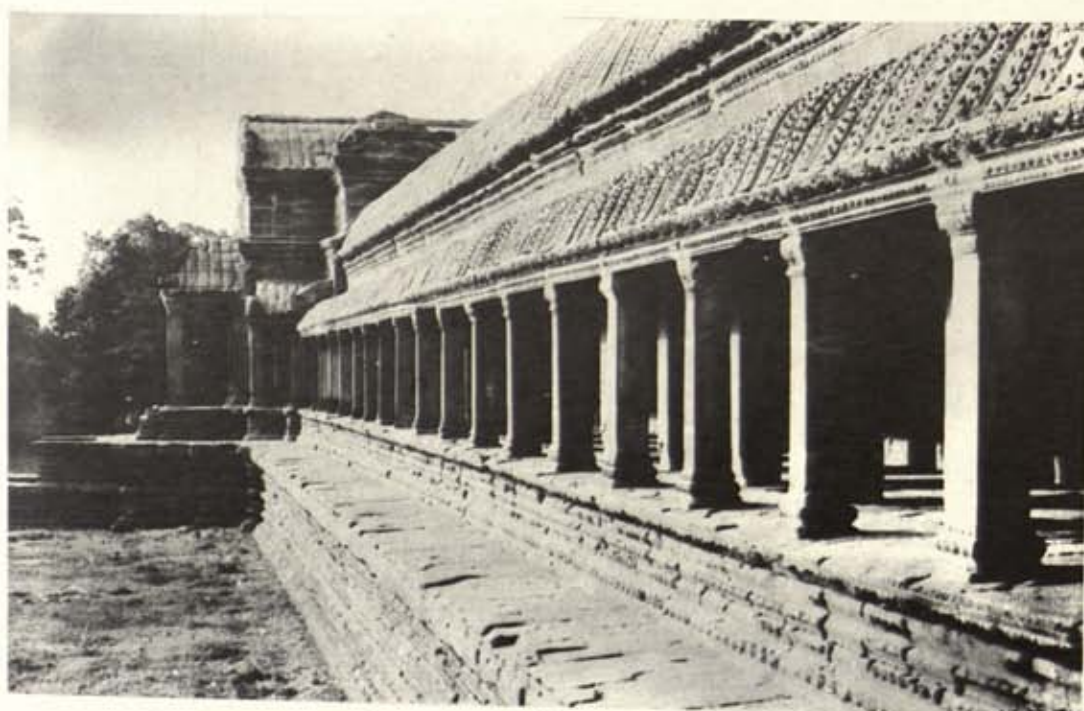
*Third Enclosure : Southern Gallery on eastern side (Samudramanthuna Gallery), A, before
and B, after conservation*

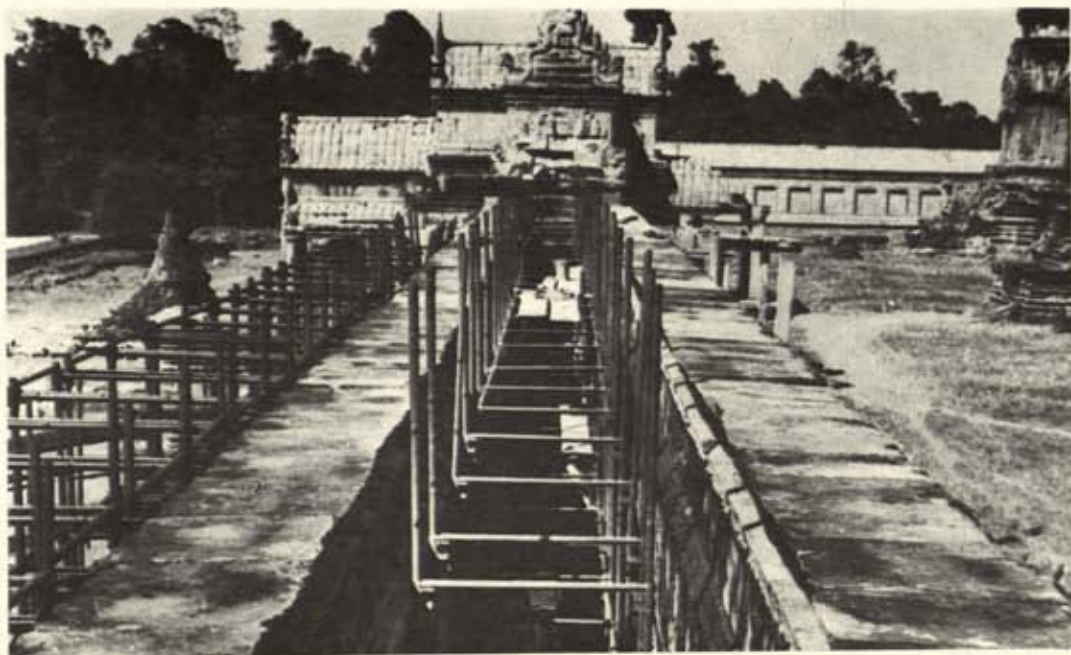
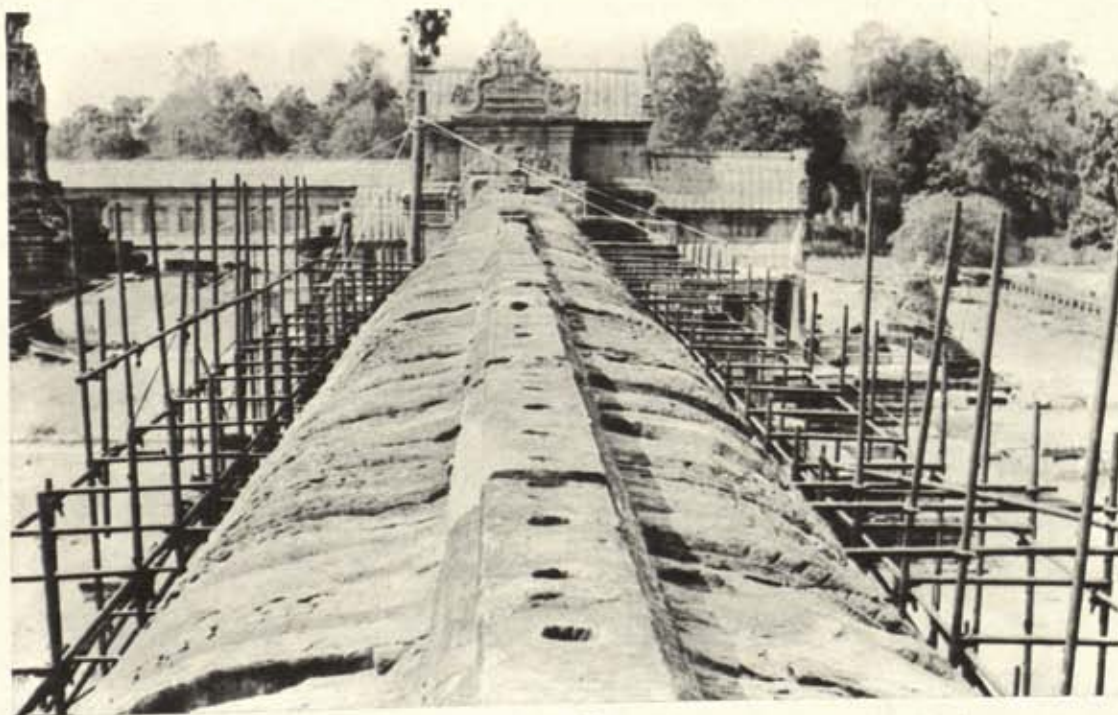
*Third Enclosure : Southern Gallery on eastern side (Samudramanthana Gallery), A, during
and B, after conservation*

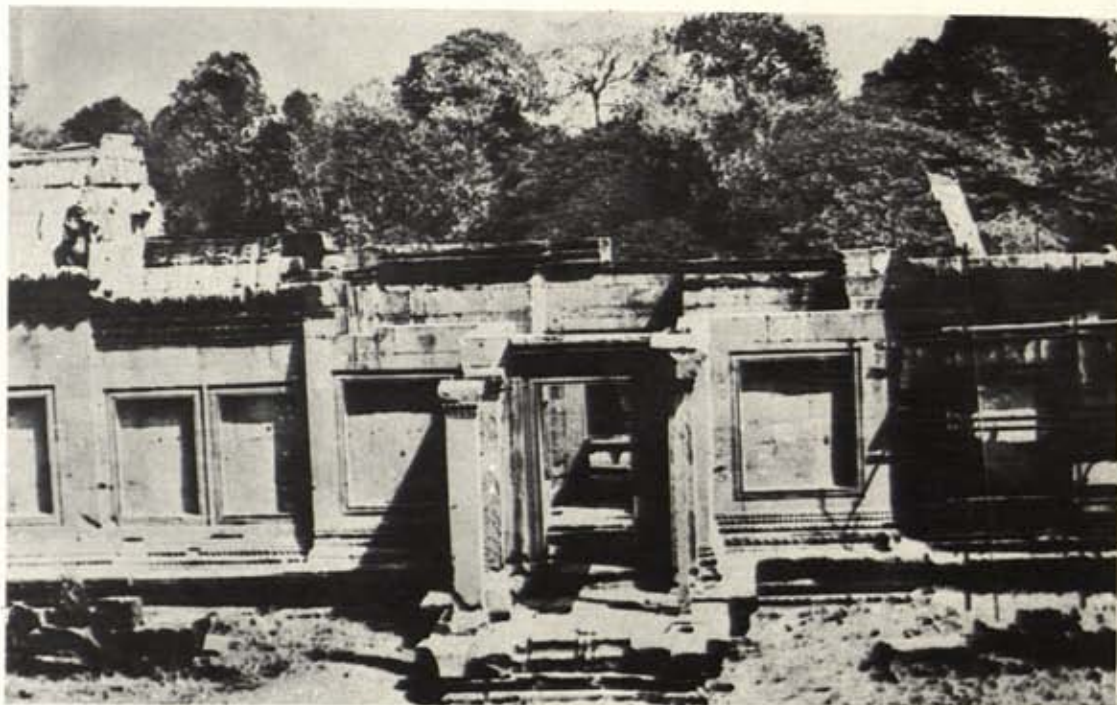
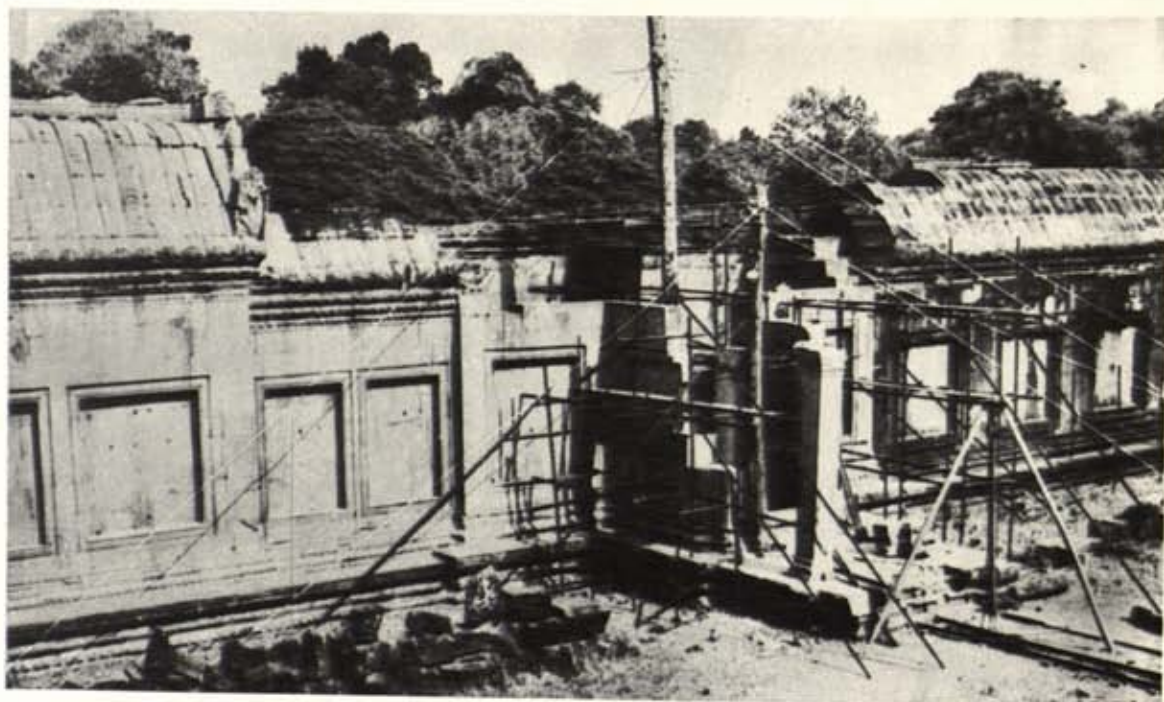
Third Enclosure : entrance pavilion north of Samudramanthana Gallery, A, before and B, during conservation

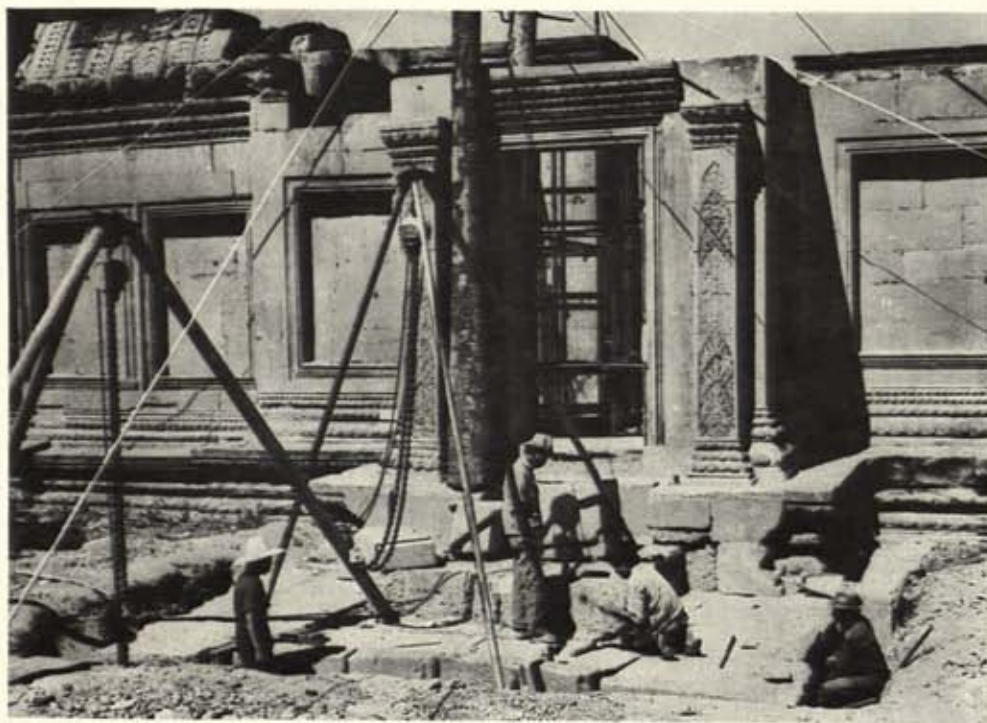
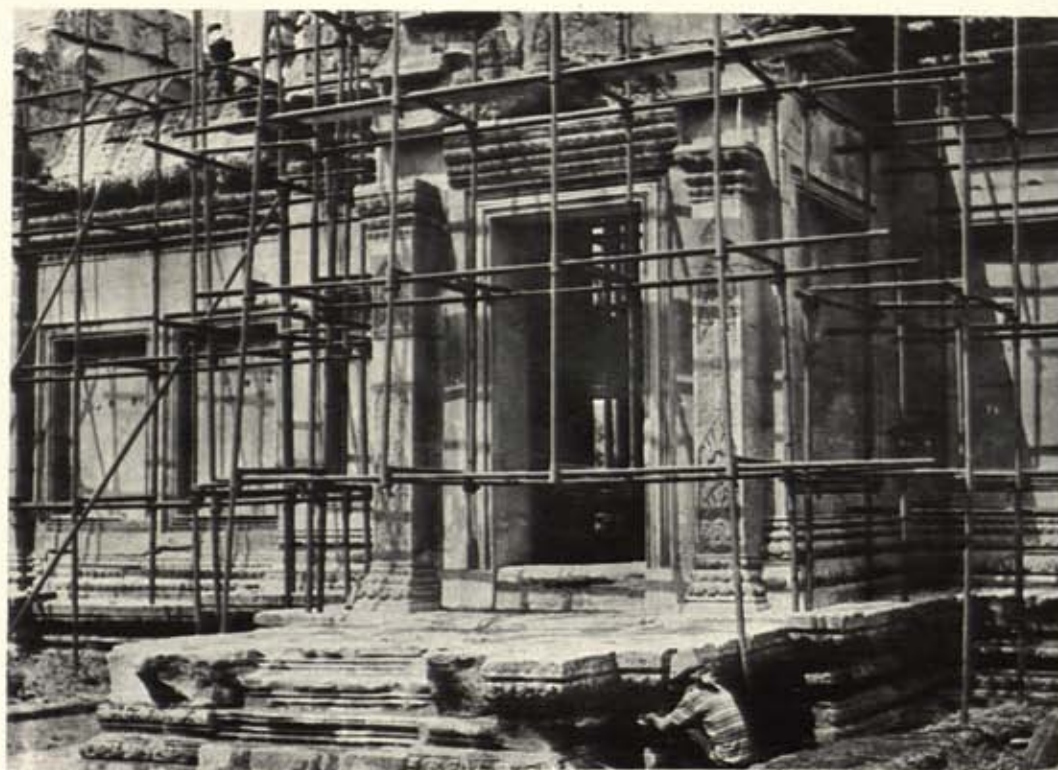
Third Enclosure : entrance pavilion north of Samudramanthana Gallery, during conservation

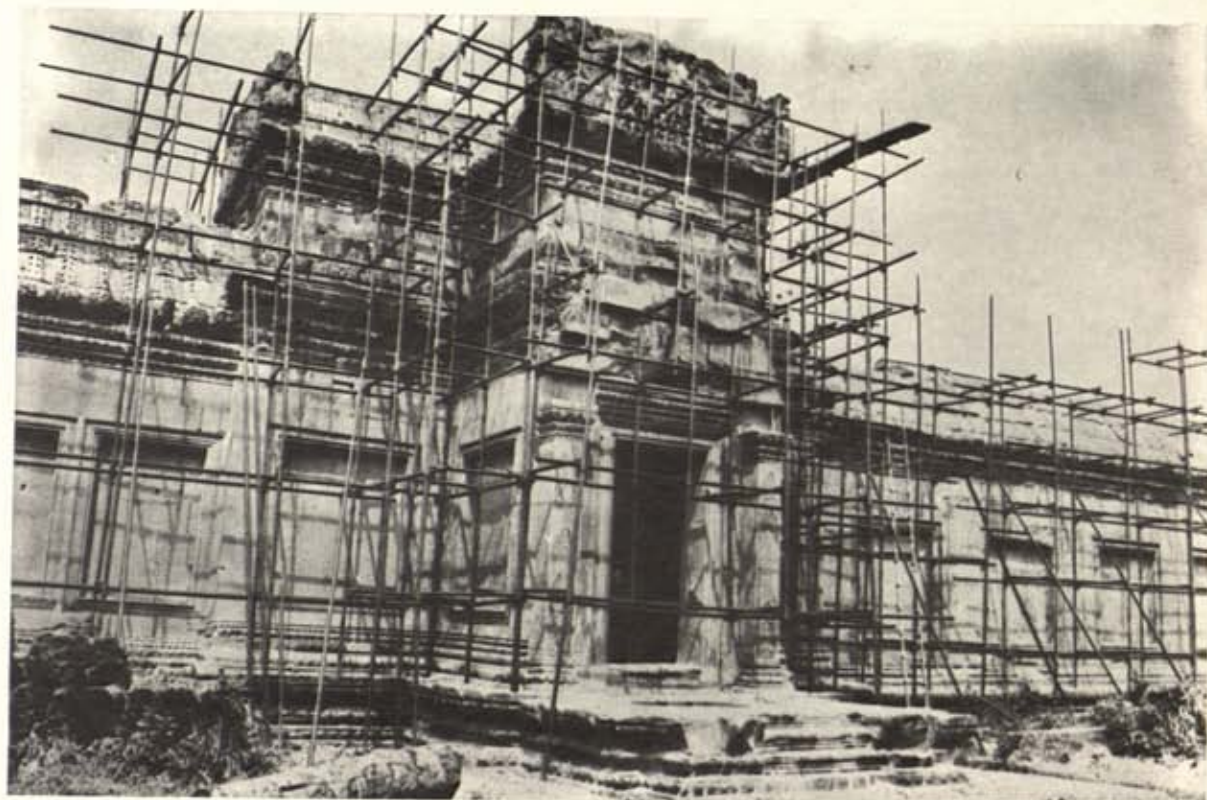
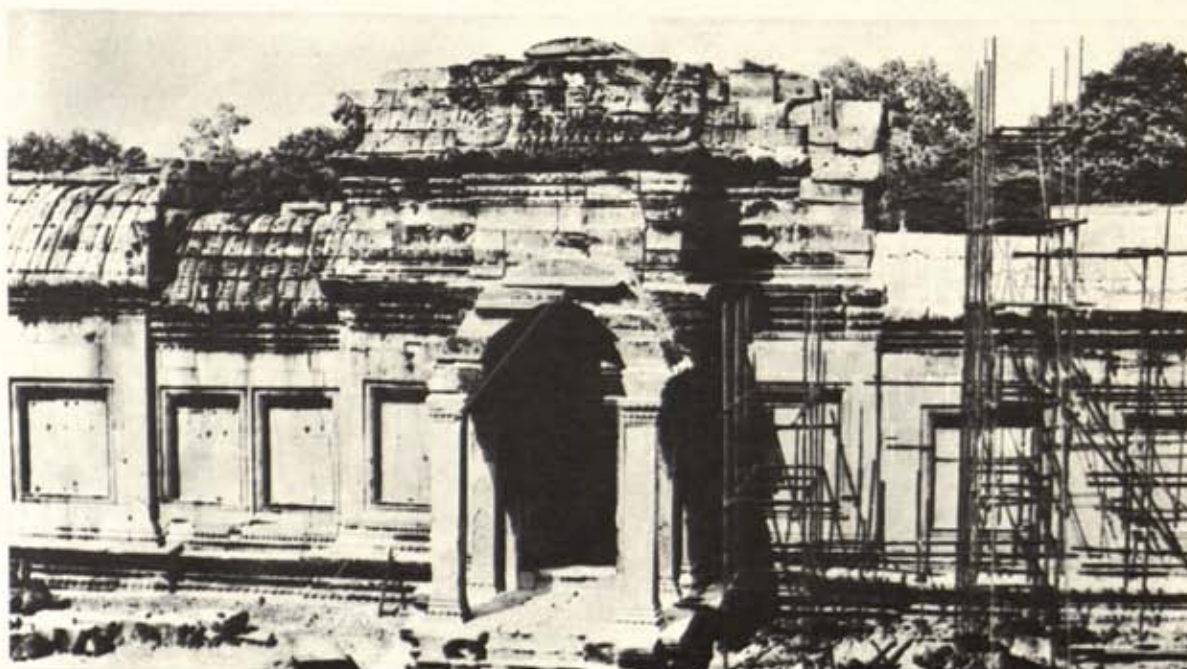
Third Enclosure : entrance pavilion north of Samudramanthana Gallery, A, during and B, after conservation

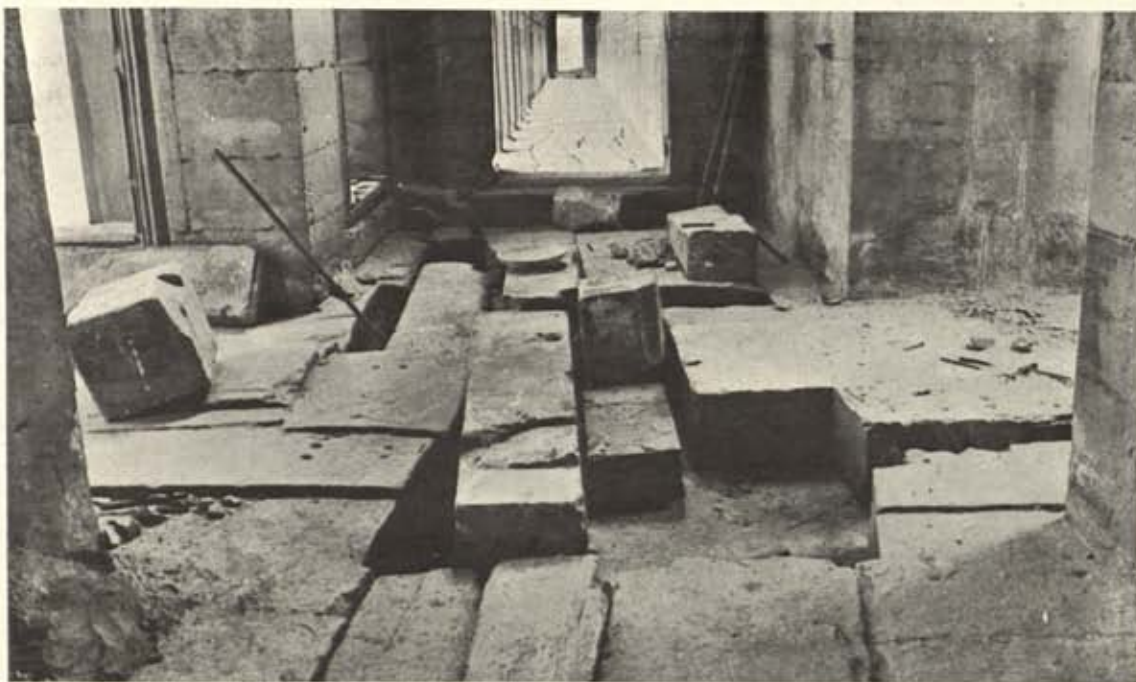
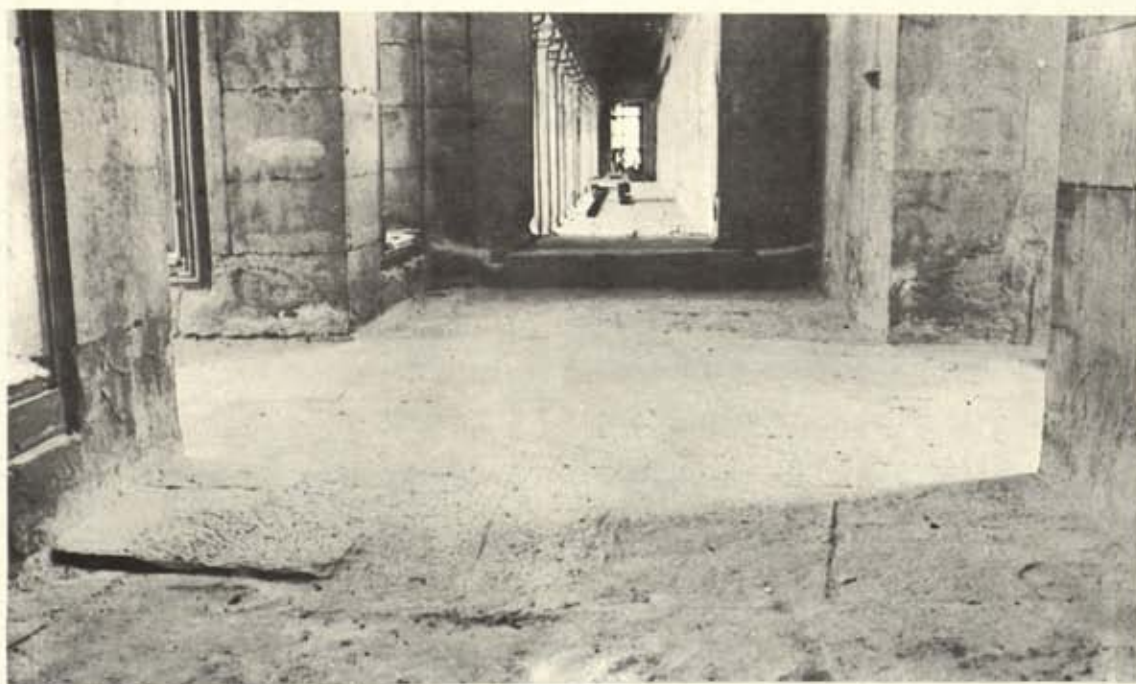
Third Enclosure : flooring, entrance pavilion, A, before and B, after conservation

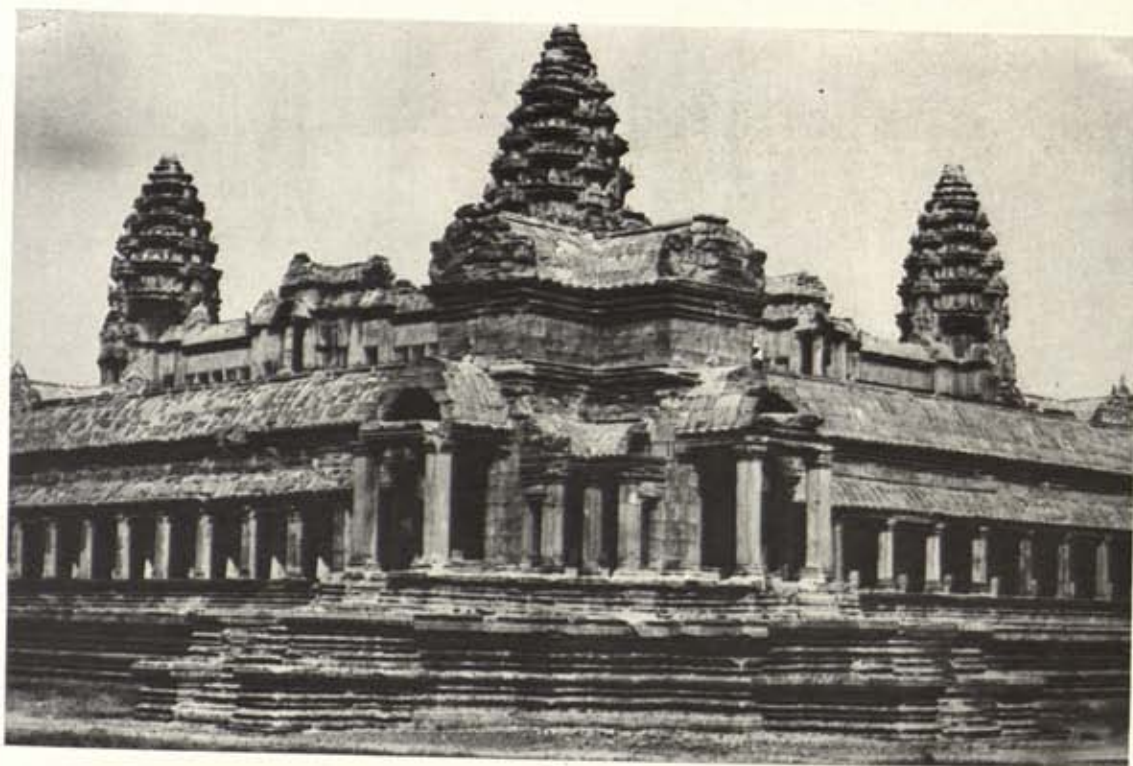
B

*Third Enclosure : south-eastern corner entrance pavilion with porches, A, before
and B, after conservation*

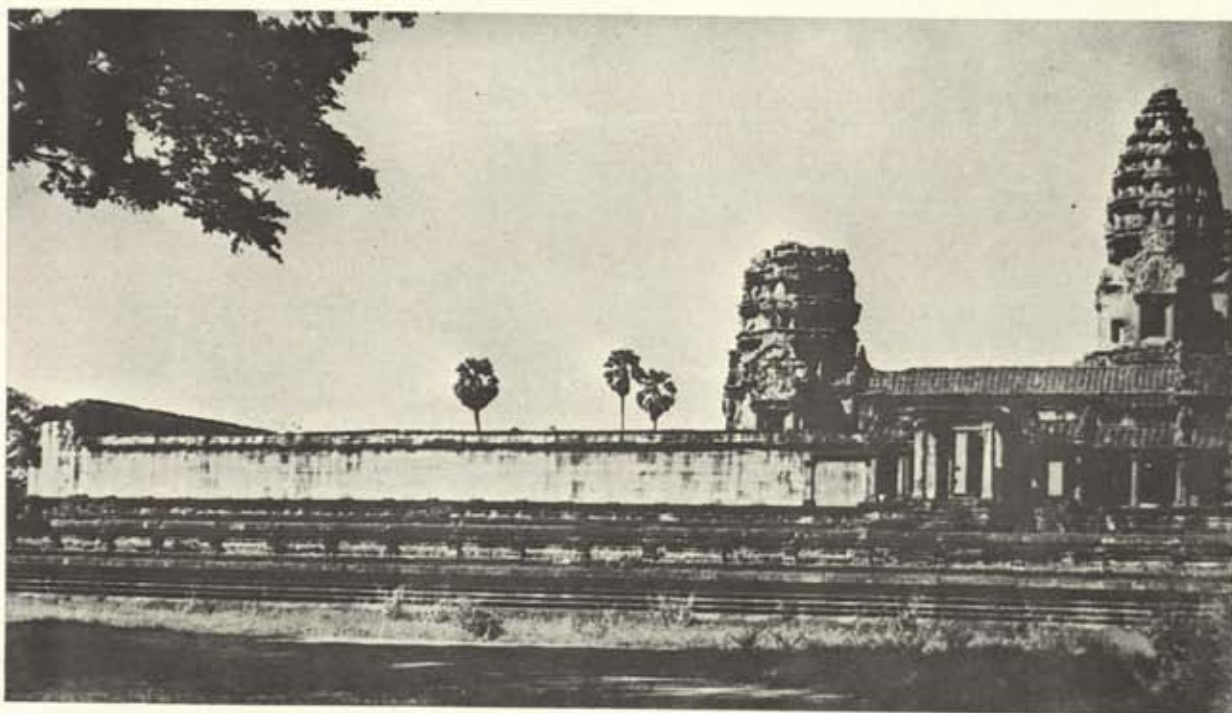
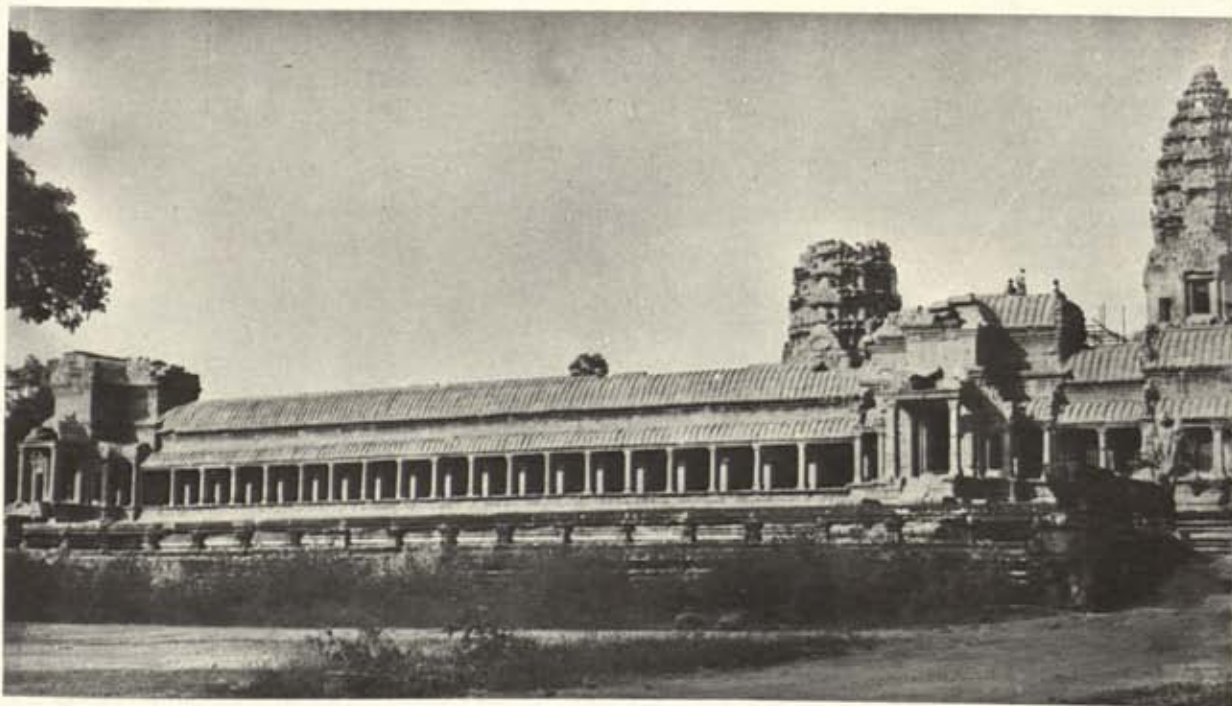
Third Enclosure : Samudramanthana Gallery and flanking entrance pavilions, A, before and B, after conservation

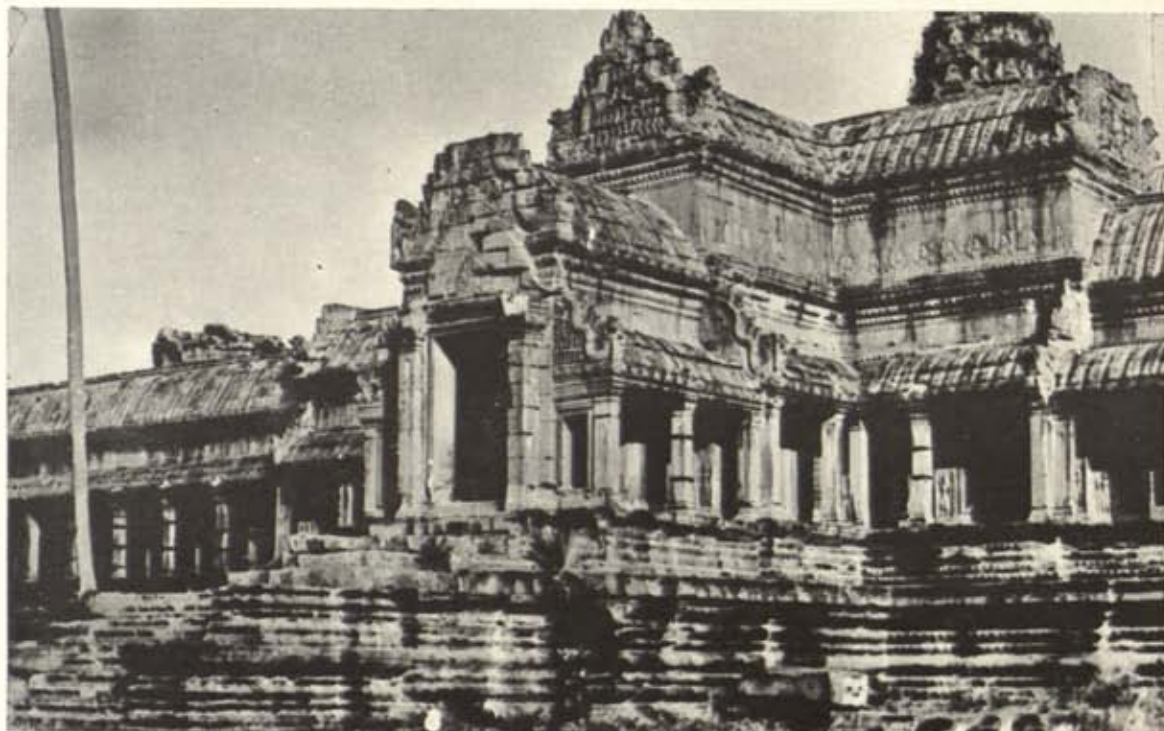
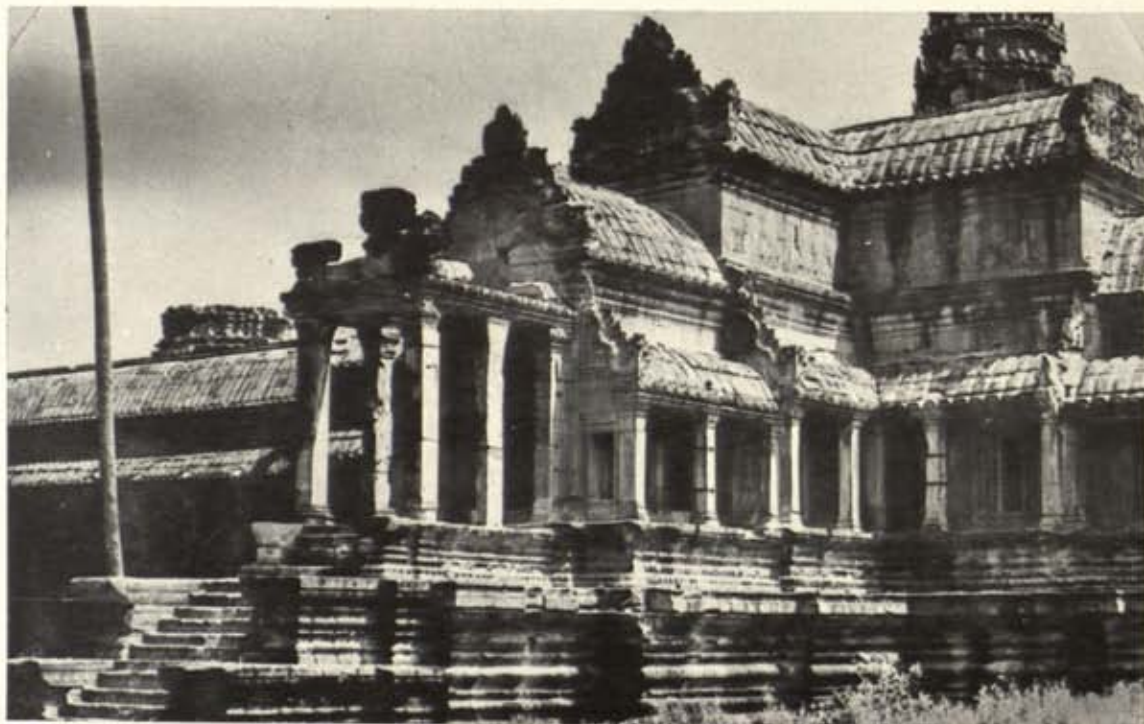
Third Enclosure : southern-central entrance porch, A, before and B, after conservation

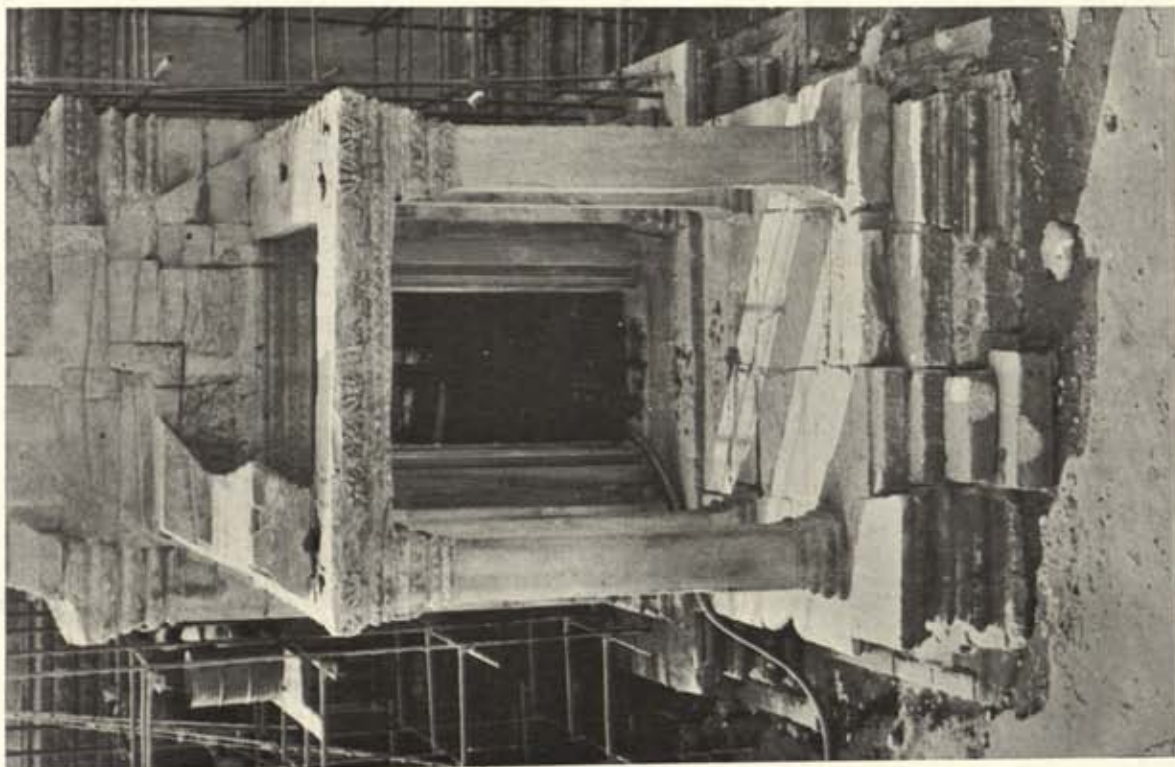
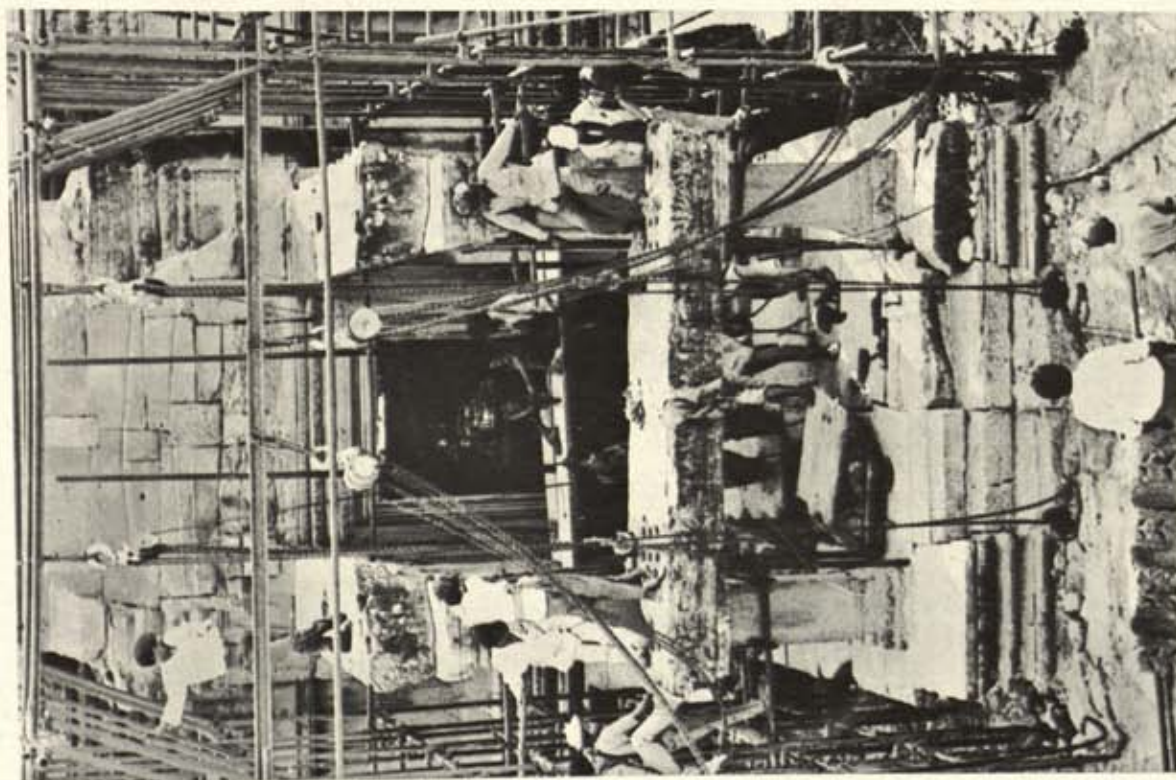
Third Enclosure : inner entrance porch on southern side, A, during and B, after conservation

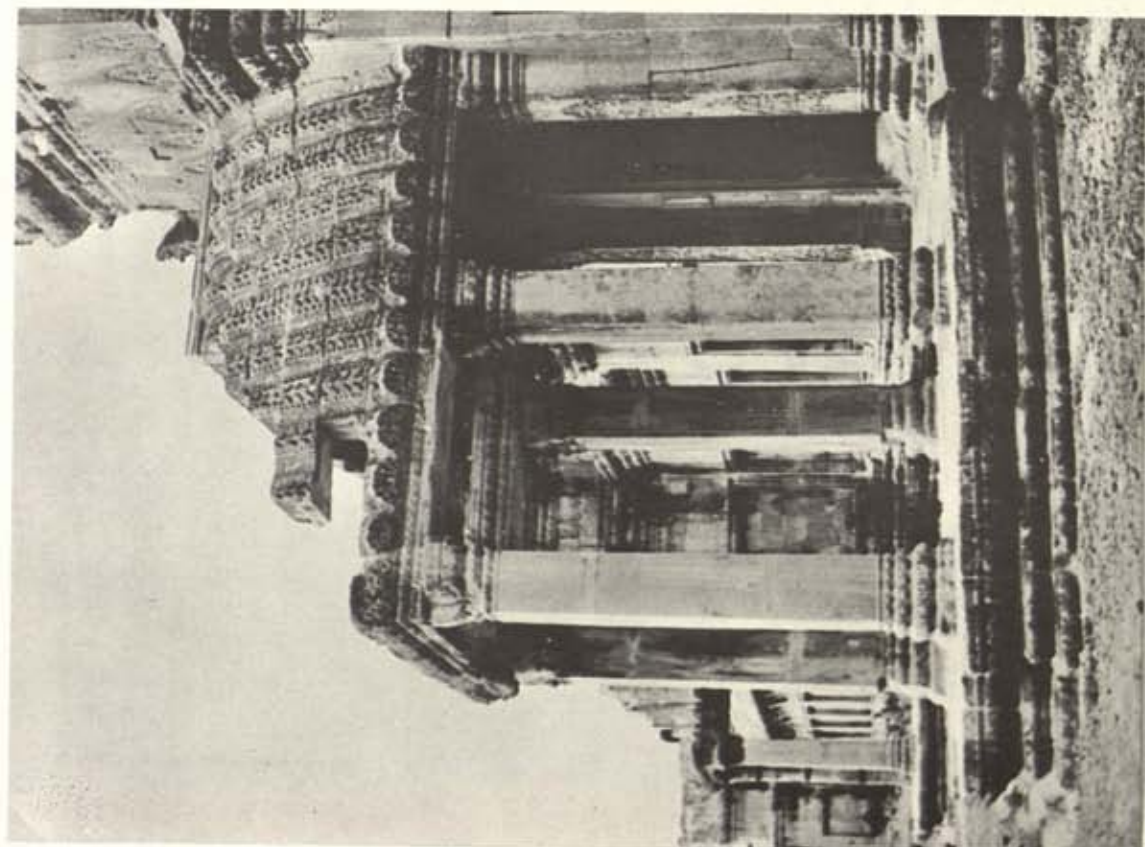
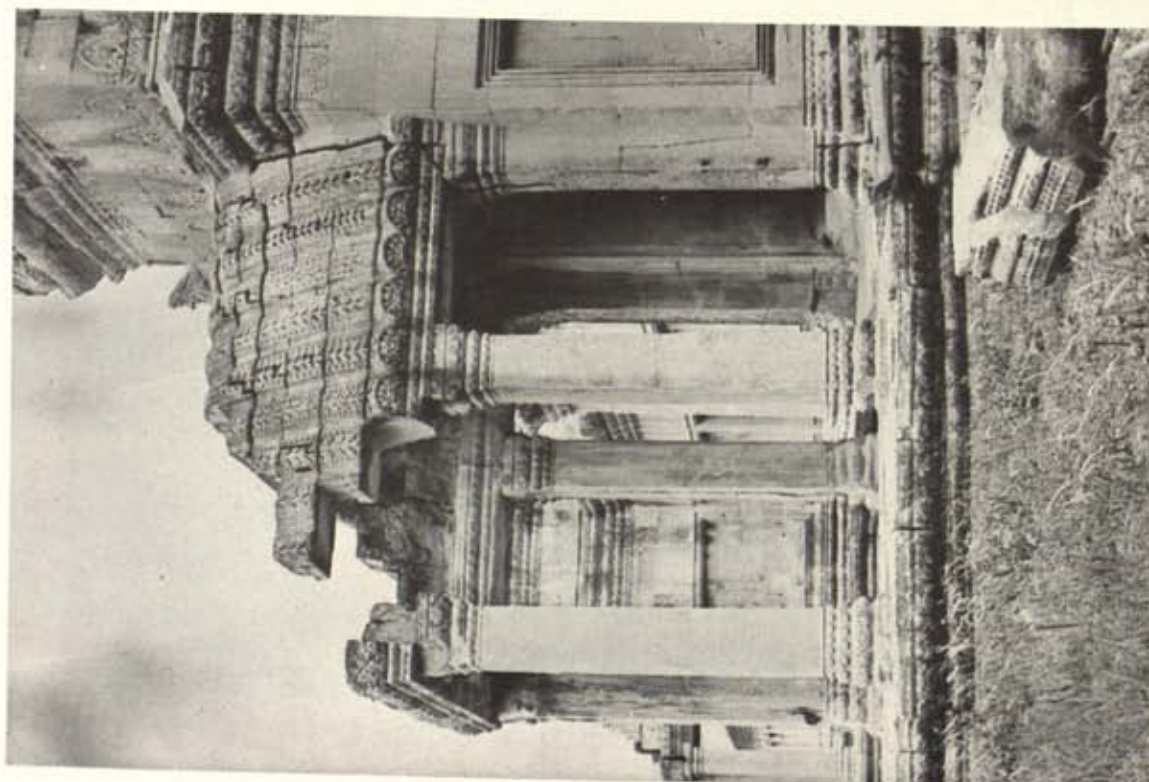
Third Enclosure : central inner entrance porch on eastern side, A, before and B, after conservation

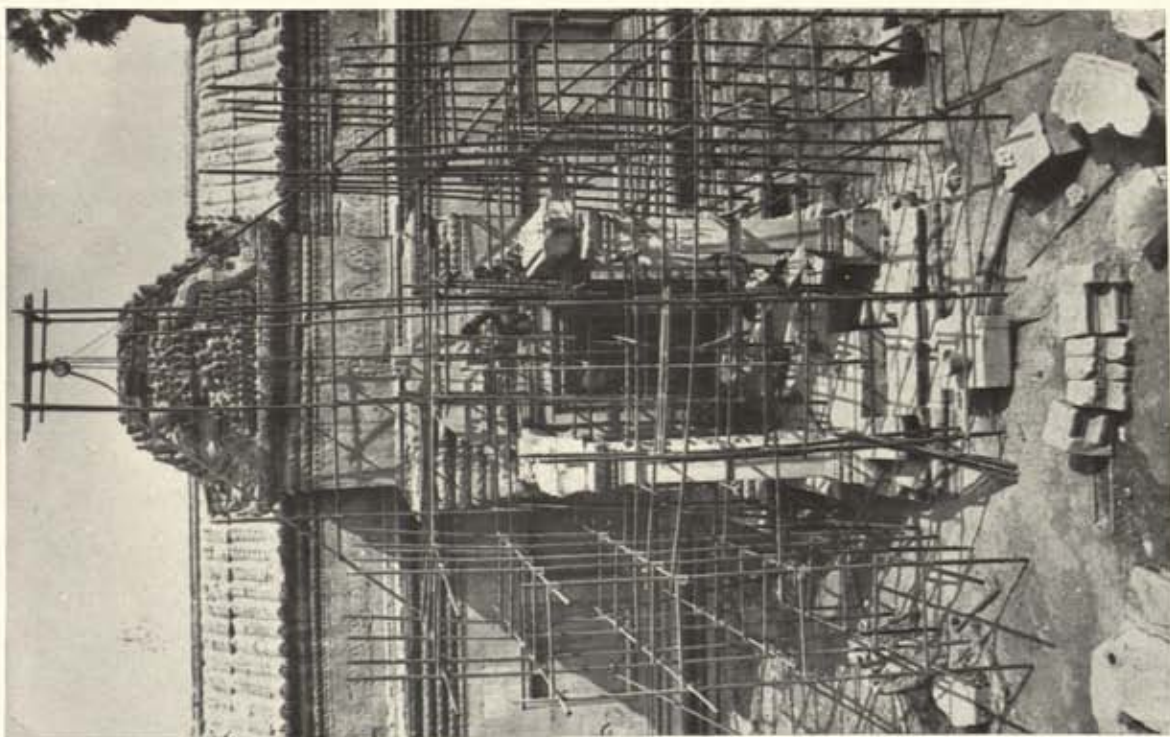
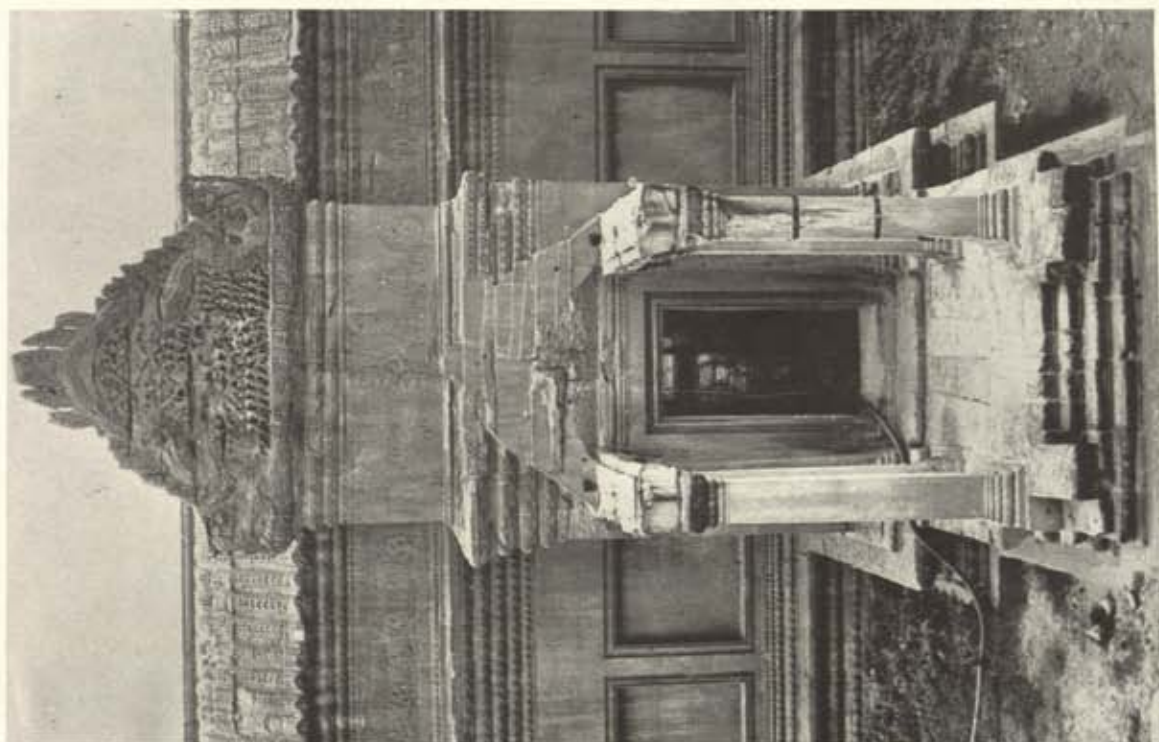
Third Enclosure : inner entrance porch on northern side. A, during and B, after conservation

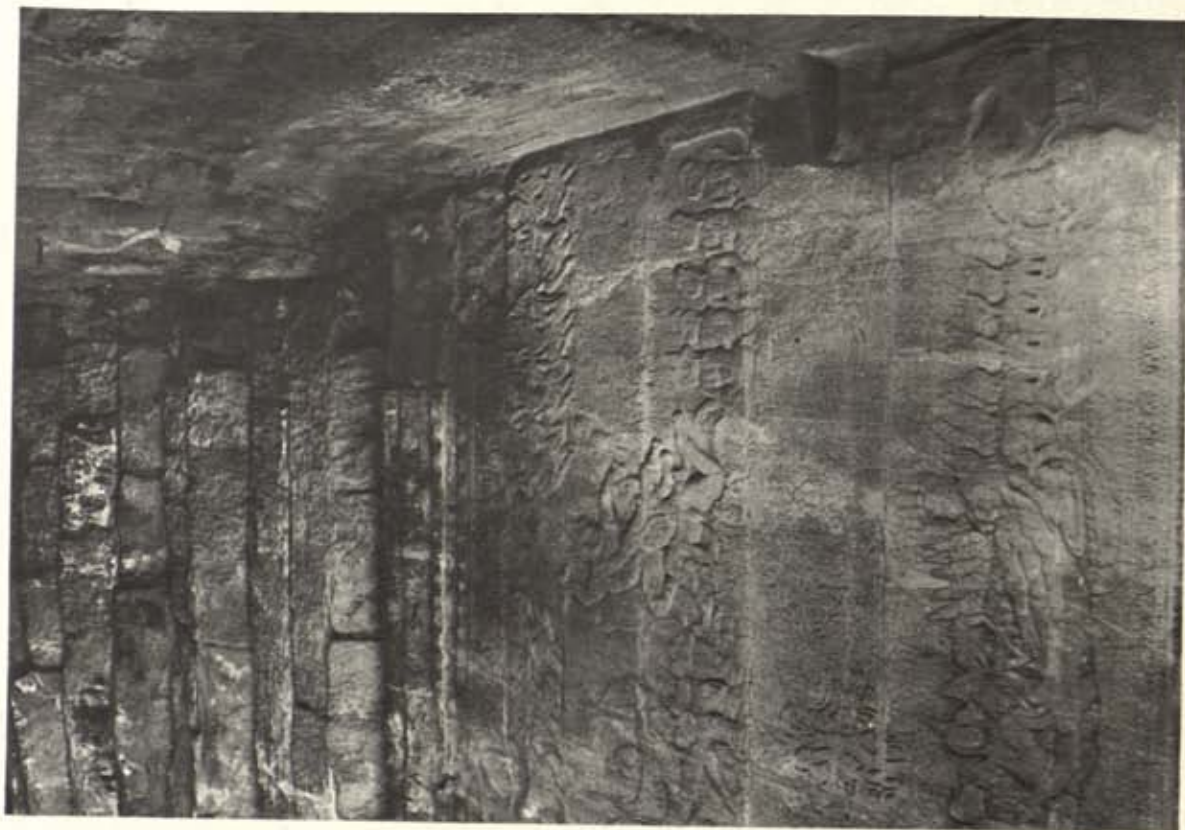
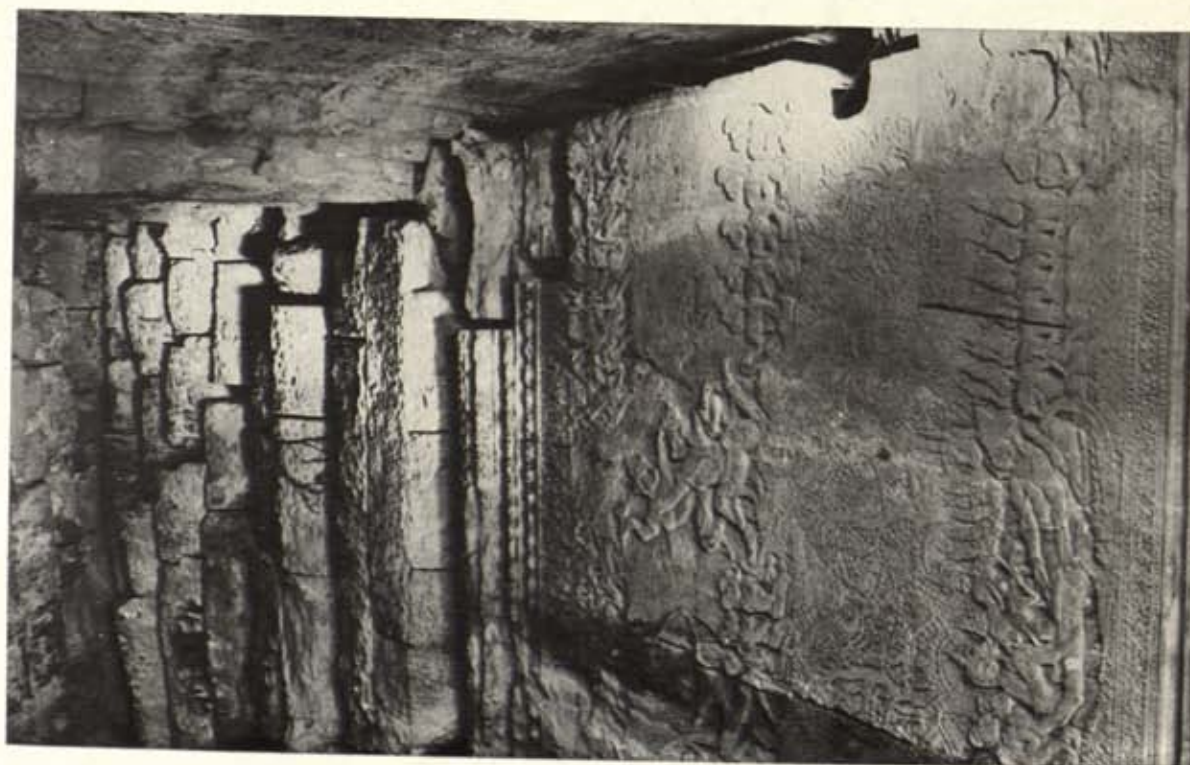
Third Enclosure : south-western corner entrance pavilion, A, before and B, after conservation

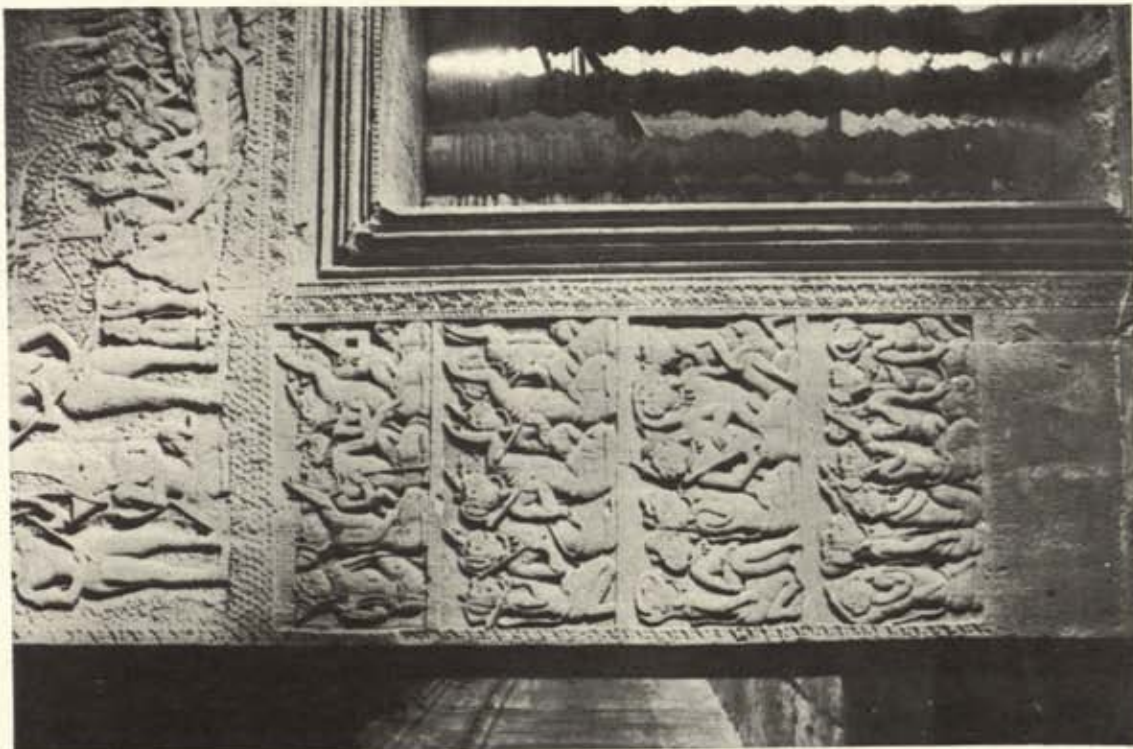
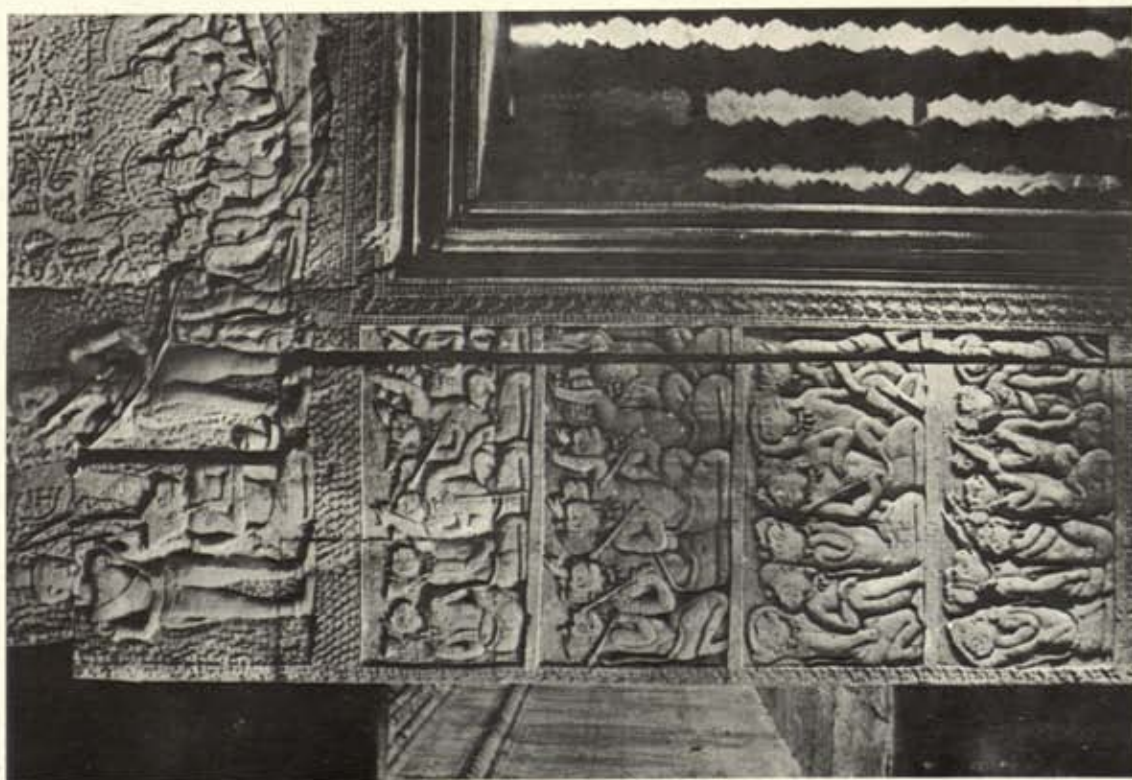
Third Enclosure : south-western corner entrance pavilion, A, before and B, after conservation
